CONDITIONS ASSESSMENT REPORT
of the
SOLDIERS AND SAILORS MONUMENT
located in
WATERTOWN, NEW YORK

Justine Posluszny Bello, Conservator
Conservation Solutions, Inc.
301-943-8249 *c*
866-843-1774 *f*
August 3, 2009

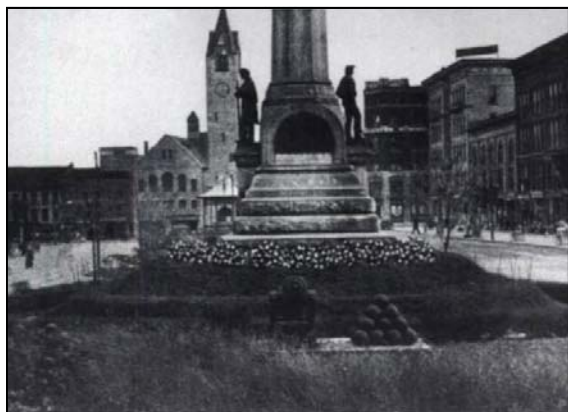
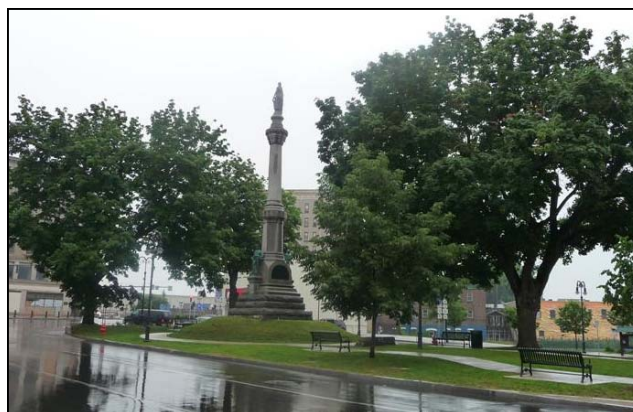
An historic photograph from the day of the monument's dedication shows that the rubble foundation course was not originally intended to be seen, but has been revealed due to soil erosion. Recent photographs supplied by the client showed a small bed of flowers encircling the base of the monument (now absent), probably an effort to partially camouflage the foundation. Landscape fabric had become partially exposed, suggesting an effort to mitigate erosion. An undated photograph, probably taken in the early twentieth century, also shows that the berm had at one time been noticeably terraced, and the site ornamented with at least one mortar and a pyramid of cannon balls. No documentation had been found to explain the removal of these elements.

Figures 6 and 7. An historic photograph (left; undated) illuminates some of the changes the site has undergone over the years. [Photo care of Donna M. Dutton, *Images of America: Watertown* (Mount Pleasant, SC: Arcadia Publishing, 2001), 14.]

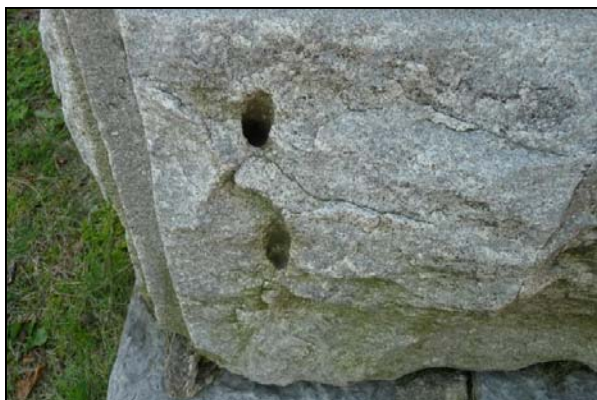
incipient spalls are inherent to this type of dressing and do not indicate significant deterioration or failure. Several (3-4) small cylindrical, voids were observed on the base of the monument; these are related to the mechanically techniques used to originally quarry the blocks and likewise do not represent any failure of the stone.

Figure 8. Example of voids caused during original construction.

The fractured corner of the cyma should be reset and the joints sealed to prevent further water ingress. The minor cylindrical voids should also be filled with an appropriate patching mortar to prevent unnecessary water ingress.

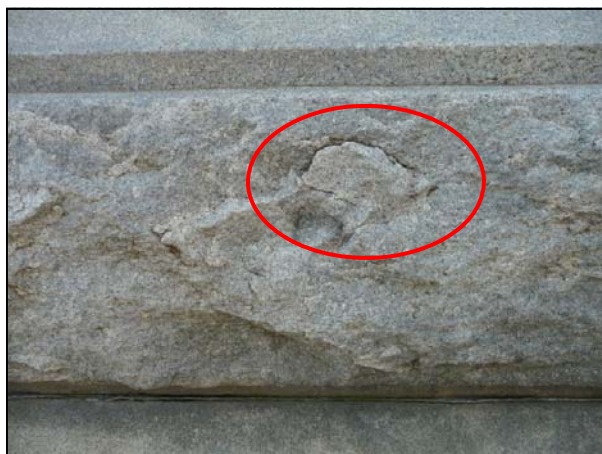
The stonework of the monument is in fair to good condition. The massive granite blocks generally remain quite sound. The three rusticated tiers of the base as well as the octagonal segment of the plinth exhibit mild to moderate surface deterioration due to the development of microfissuring caused by the original pitch-faced dressing of these stones. These minor losses and

Figure 9. Minor incipient spalls on the face of the base stones are due to the original technique used to create the pitch-faced finish of the stone.

As minor incipient spalls on the rusticated surfaces of the base are inherent to this type of dressing and do not indicate significant deterioration or failure, these fragments do not require stabilization or reapplication.

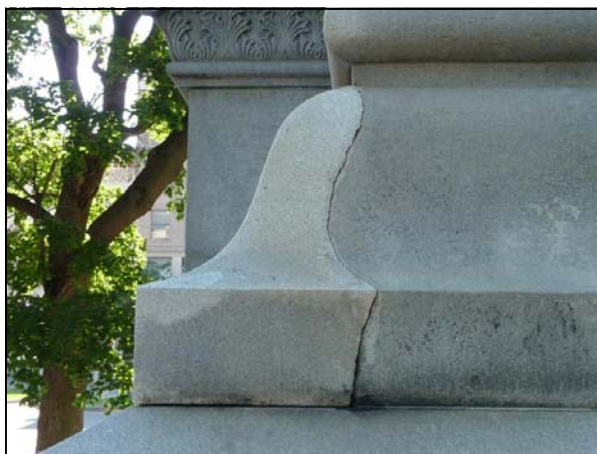
The southeastern corner of the cyma has cracked due to point-loading, resulting in fractured piece which remains in place. This piece, approximately 6" x 12" x 18," does not appear to be in immediate danger of falling off the monument but should be stabilized.

Figure 10. Point-loading has caused one corner of the cyma level to separate at a fracture line.

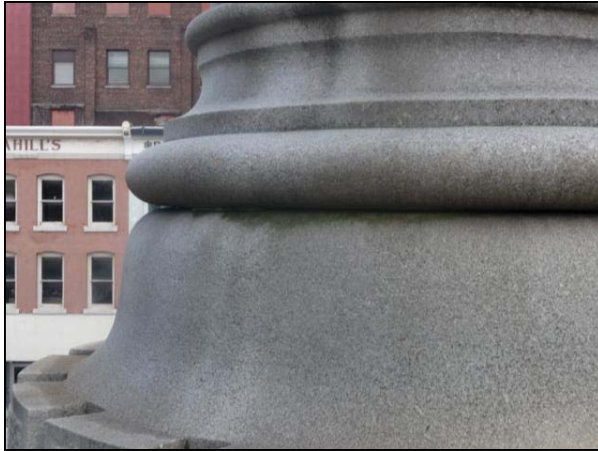
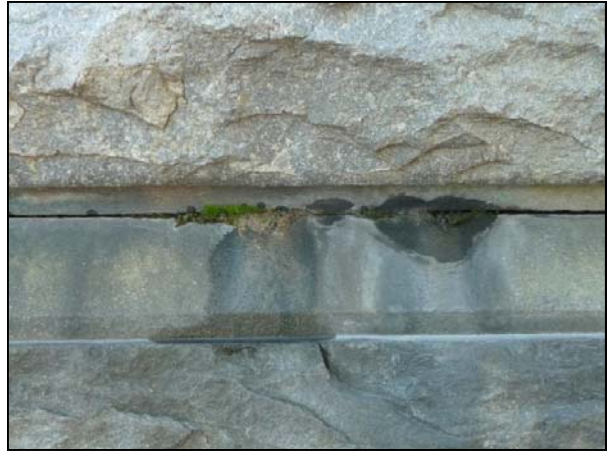
Soiling of the monument is fairly mild. Black soiling has accumulated in the recesses around joints and below the crenellation, in predictable patterns indicating the path of water run-off. The greatest concentration occurs on the three rusticated tiers of the base, where atmospheric and biological soiling (both green and black) has accumulated on the undulating surfaces and along the edges of emerging flakes. Moist, green biological matter and moss are growing out of the wide, damp joints of the foundation as well as the narrow joints of the base and lower plinth. Soiling generally tends to be heavier on the north and west elevations, which receive less sun light and will stay damp longer. The figure of *Victory* exhibits bird droppings and limited yellow/orange discoloration of the stone, which may be mild rust staining.

Figures 11 and 12. Soiling and biological matter has accumulated in the recesses approaching joints (left), and in joints which remain damp.

All granite surfaces should be cleaned with an anionic detergent. Triton X-100 should be diluted 1 part concentrate to 100 parts water. Areas of soiling should be further washed with detergent using gentle scrubbing with soft brushes followed by water rinses.

D/2 Architectural Anti-Microbial, or approved equal, should be used to removed biological

soiling. Concentration will be determined through testing. Areas of biological growth will be removed using gentle scrubbing with soft brushes followed by water rinses.

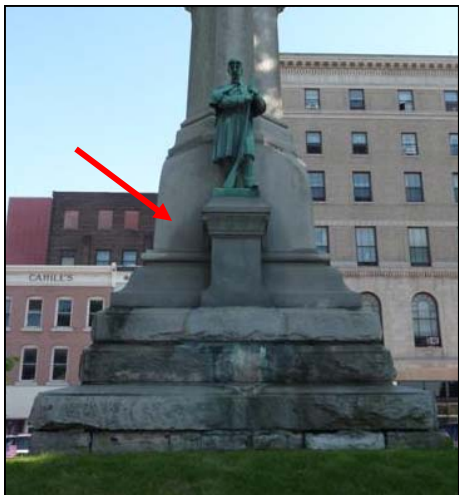
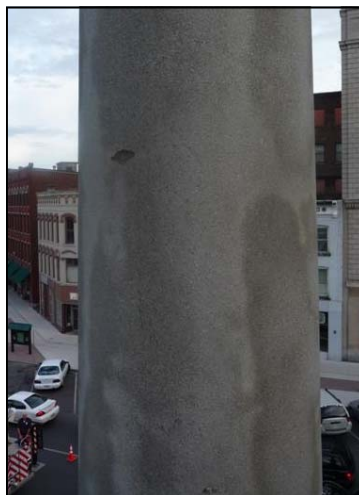
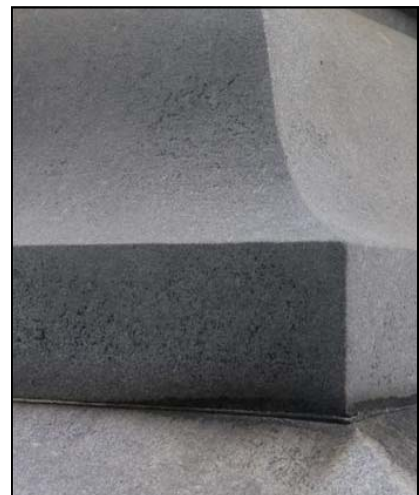
The granite exhibits some unevenness of color, in areas such as the “backsplash” behind each of the bronze figures. The shape of a monument will necessarily encourage water to dwell longer on some areas of the stone than others; through weathering and exposure, feldspar in the granite will be converted into kaolinite (clay). The clay subsequently washes out of the stone, leaving the darker minerals present. The resulting coloration is a direct result of the stone’s morphology and should not be considered a fault or problem, nor is it a condition which can be reversed.

Figures 13-15. The stone exhibits some unevenness of color due to variations in weathering (left and center), leaving some minerals more exposed (detail, right).

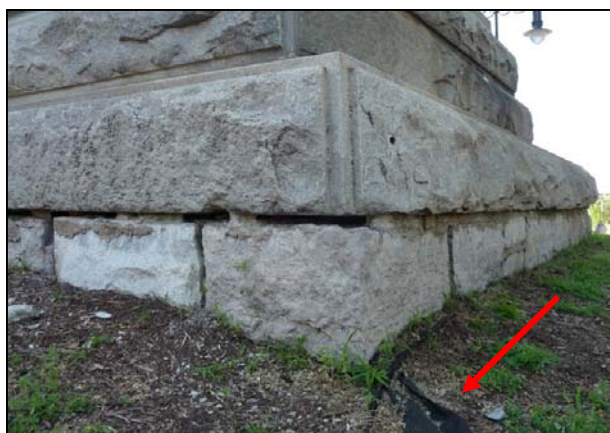
Figure 16. General condition of the foundation (lower course). Also note the emergence of the landscape fabric.

The joints of the rubble foundation course are wide, ranging in width from approximately 3/4" to 1 1/2." The condition of the mortar is generally poor. The joints have probably been re-pointed multiple times, with significant overruns beginning to accumulate on the adjacent stone. This is the only significant evidence of any prior treatment or intervention. Approximately one-third of the pointing mortar is missing; a significant portion of the bedding mortar has been lost as well, up to a depth of 1 to 2 inches. However, the foundation does not otherwise exhibit any signs of movement or failure.

All existing pointing mortar, including inappropriate overruns, should be carefully removed using hand tools. To ensure the deepest recesses of the rubble course are well-bonded and stable, these joints should be filled using an injection grout. The faces of the joint should be partially dammed with an appropriate mortar. A low-viscosity grout should then be injected behind the dam to flow through the foundation, filling openings between stone units which would have otherwise been inaccessible. The injection ports should then be pointed to match the surrounding mortar.

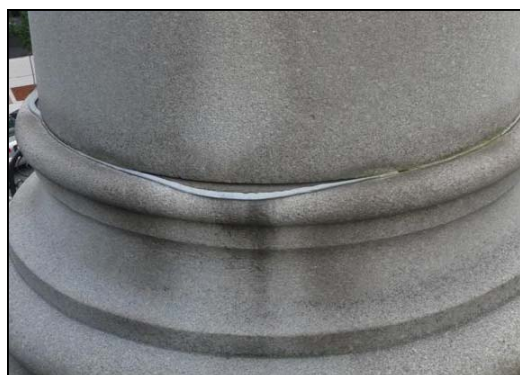
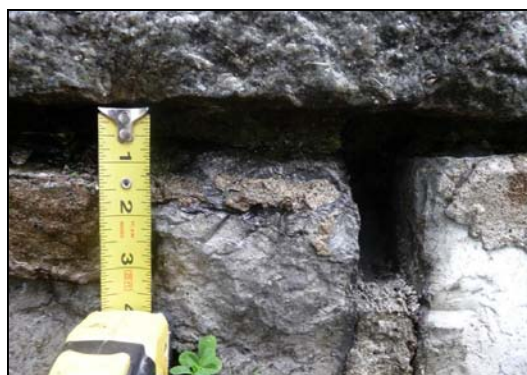
The joints between granite units are generally narrow, typically 1/8". It is likely that the granite blocks were dry set on lead buttons after which each joint was pointed with a lead strip. The joints are in poor condition. The existing lead is deteriorating, displaced or wholly missing from many of the joints, particularly between the second and third tiers of the base, as well as at various heights along the length of the shaft. The lead between each bronze figure and its granite plinth has also generally failed.

Figures 17 and 18. Example of a typical lead strip caulk dislodged from its joint (left) and one of the many wide, open joints of the foundation (right).

Repairs should be made as needed to ensure all joints are properly sealed with lead. Properly sealing the joints, particularly those near the top of the monument, should discourage future moisture infiltration and the recurrence of significant biological growth or a calcite run on the base. Dislodged lead strips should be tamped back into place. Lead that is severely damaged should be removed; these and otherwise open joints will be fitted with new lead cut to the appropriate thickness and length.

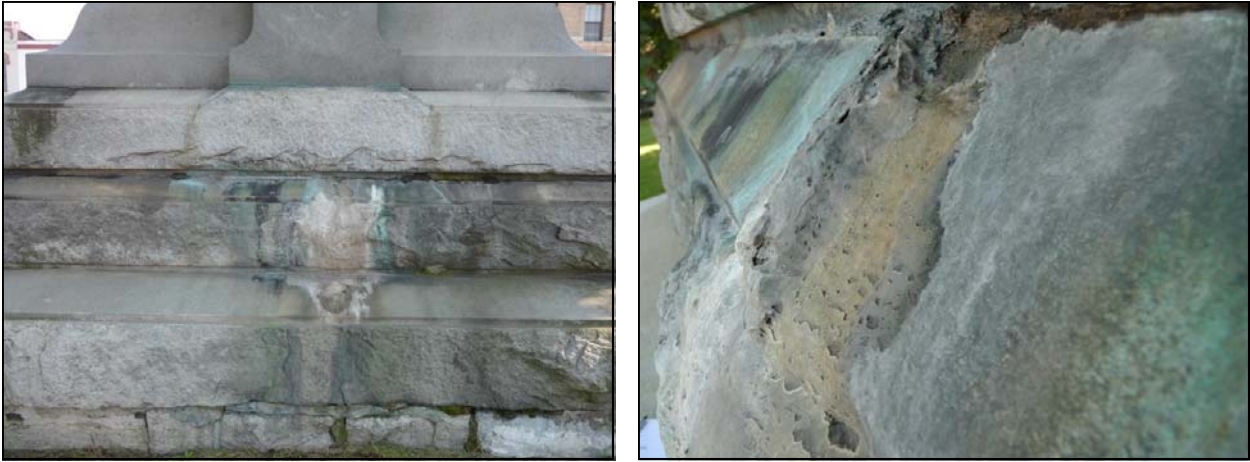
A significant calcite run has developed on the north side of the base, the only incidence of this phenomenon. The deposit originates from the joint between the second and third tiers of the base, immediately below the plinth of the sailor. The accretion is concentrated on the face of the second tier and the upper pitch of the lowest tier. Copper staining, atmospheric and biological soiling have become incorporated into the accretion as well. The location of the accretion indicates that as water washes through the mostly open joint it is carrying minerals along with it, which are being deposited as the water runs down the stone below. The source of the cal-

cium hydroxide that has been dissolved and deposited is not apparent as the blocks are monoliths nor is the water source obvious.

Figures 19 and 20. Overall (left) and detailed image (right) of the dense calcite run which has developed on the north elevation of the base.

The calcite run and biological soiling on the base of the granite stand out as the most anomalous among the conditions observed of the monument. Although it is clear that water is exiting the

joint at this location, the source of this water is less obvious. Because the tiers are monolithic, there are no vertical joints that could serve as possible sites of water ingress. The source of the calcite being deposited is also unclear. Normally a deposit of this type would be traceable to mortar and/or a carbonate stone itself, neither of which are seen in this situation.

It is possible that there is an internal core or doweling system through the center of the monument, such as one built of brick or concrete. This could be acting as a channel through which moisture is migrating through the monument, dissolving un-reacted lime in the core and carrying it out to be re-deposited. However, without further historic documentation or an invasive probe, this condition remains unconfirmed.

The calcite run should most likely be eliminated through careful mechanical removal, using a variety of hand and powered Dremel tools. Extreme care will be taken to avoid scarring underlying surfaces. Mechanical cleaning may be followed by micro-abrasion (JOS Cleaning) as needed to remove remaining scale and blend the edges of the cleaning site. Alternatively, the

deposit may be dissolved using nitric acid, a solution which will not react with the granite substrate.

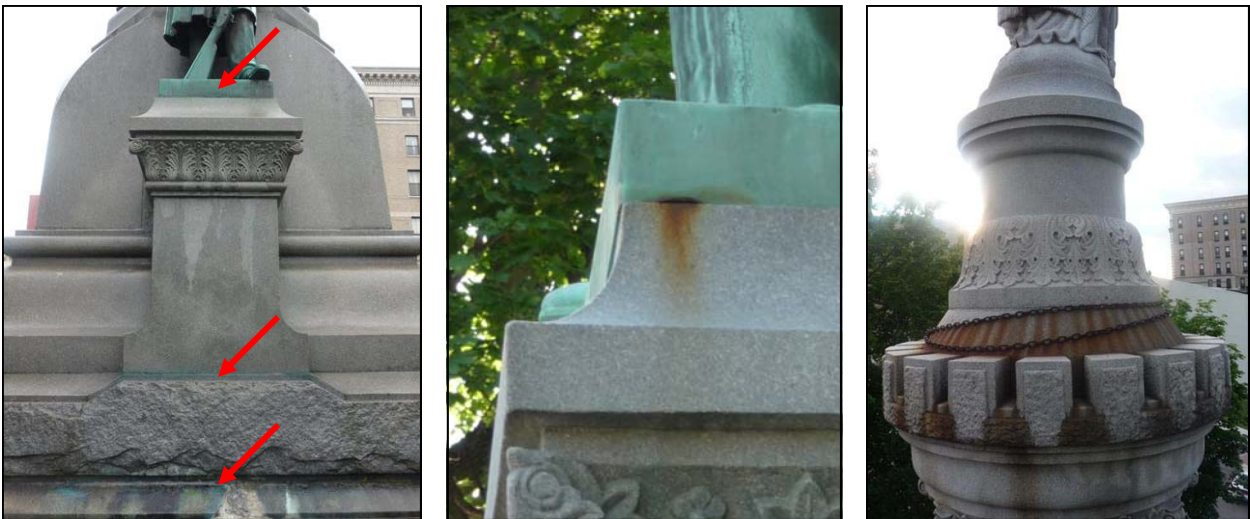
Metallic staining has occurred at various locations from two sources. Copper staining has predictably occurred on the granite immediately below the bronze figures and plaques, and is visible as a light blue-green wash on the faces of the stone.

Significant iron staining was observed concentrated on the upper level of crenellation, with a lesser, minor stain visible near the foot of the sailor. Subsequent observations made from the aerial lift showed that an iron chain, approximately four feet long, is wrapped around the pedes-

Figures 21-23. Examples of copper staining (left), mild and significant rust staining (center and right, respectively) on the monument.

tal of *Victory*, resulting in the staining below. The representative of the fire department did not consider it safe to attempt to remove the chain at this time. From this vantage point, we also observed that a ferrous shim used to level the figure of the sailor is causing that stain.

Following detergent cleaning, copper stains should be removed by poultice cleaning using ammonium citrate in attapulgite clay. The stone surrounding the stain should be masked with blue tape and/or plastic sheeting. The chemical will be mixed with powdered clay until a workable paste consistency is achieved, and applied to the stain in an even thickness using plastic trowels. Areas will be shaded as needed to avoid uneven drying; the poultice will be monitored, and adjacent areas may be misted to force evaporation away from them and to the poultice.

When the clay has dried sufficiently, it should be scraped off the surface with plastic scrapers, contained, and disposed of accordingly. Residual clay will be dry-brushed from the surface and then thoroughly rinsed with pressurized water. The stone should be allowed to dry and reassessed, and the process repeated as needed. Removal of embedded copper stains should only be performed by highly experienced conservators, as improper poulticing risks leaving even more unsightly turquoise blue stains.

Iron stains should be removed using a solution of Iron Out or approved equal. A dilute solution will be applied following the manufacturer's recommended procedures to the pre-wetted stone surfaces. Adjacent surfaces should be protected during treatment. The solution should remain on the surface for the appropriate dwell time, to be determined through initial cleaning tests, after which the area should be thoroughly rinsed. The process may be repeated as needed on particularly tenacious stains.

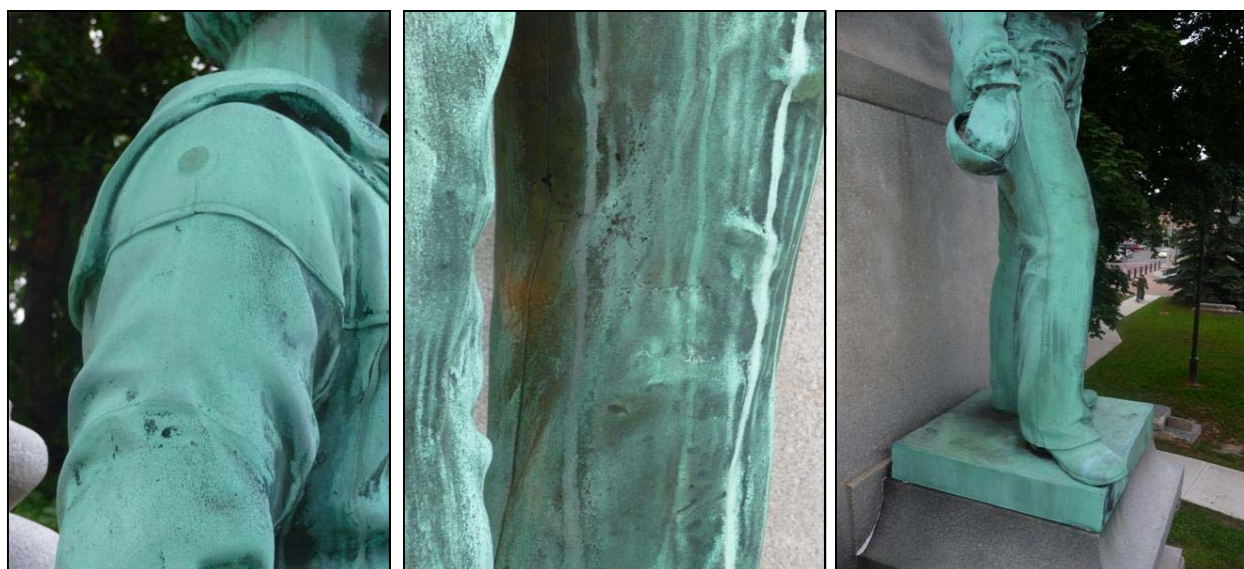
Both sculptures possess an appearance and condition similar to that of other unmaintained bronzes of the same age in an outdoor environment. Active corrosion of the bronze surface is visible by its pale green appearance, streaking, and pitting of the surfaces.

The copper corrosion products consist mainly of powdery pale green deposits (most likely copper sulfates) and a hard, rough-textured crust of matte-black deposits (most likely a mixture of copper sulfides, carbon, and other airborne particulate matter). The disfiguring streaking of the surface is indicative of the paths where

Figures 26-28. Typical condition of bronze surface (left); typical condition of streaking and incidence of rust staining (center); missing cutlass blade (right).

water runs off the sculpture. During this process the more stable black crust is being dissolved by acidic run-off and converted into the paler green soluble sulfate form. The result is a predominantly green surface with islands of raised black crusts.

Beyond this general deterioration, the figures have sustained specific damage. The blade of the sailor's cutlass is missing, however this was the only sculptural loss observed. There are no major dents, nor corrosion fully through the metal. The legs of the sailor exhibit mild rust staining, probably due to some decoration draped on or suspended from the figure at one time. Each figure is pulling forward slightly off of its stone plinth. This is most likely due to the loosening or attenuation of the pin which holds the figure to the stone.

As part of this treatment, the sailor's missing cutlass blade should be recreated. A new model should be made based upon detailed historic photographs (if available) or one of a number of well-documented Civil War era examples, to be approved by the client. A mold should be made of the sailor's hand and the extant hilt of the cutlass to ensure that the replacement will match the profile of what exists. A new model should be created in wood, wax and/or plaster. The model should be cast by a foundry experienced with bronze statuary restoration. The new casting should be attached to figure using bronze threaded rod; all rods and joints should then be welded to firmly affix the new casting to the figure. The entire element should then be patinated to blend in with the approved patination scheme of the sailor and waxed in the same

Following general cleaning, loose corrosion products should be removed from all bronze surfaces using low to medium pressurized water (2000-2500) using a 15° fan tip. Consistent tip-to-surface distance, angle and dwell time should be maintained throughout cleaning. The surfaces should be continually monitored to ensure that no bare bronze is being exposed. Remnants of previous coatings should be removed locally as needed using solvent gels and hot water or steam.

Depending upon the results achieved from the water jetting, the sculptures and plaques should then be patinated to help reduce the contrast between the areas of light green corrosion and the black sections. The desired result should be developed in consultation with the client, within the parameters of the existing patina and what can be achieved using typical hot and cold patination techniques.

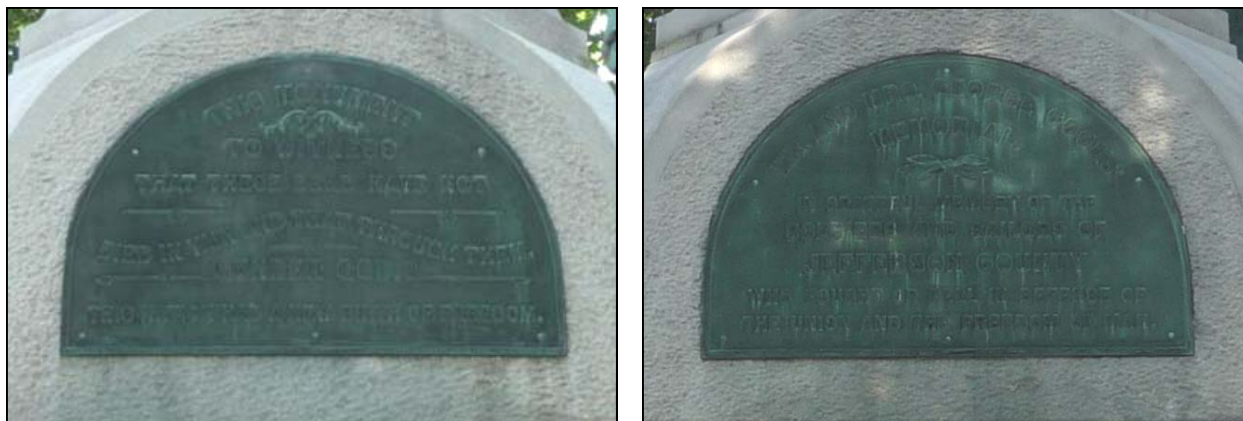
The plaques exhibit surface deterioration similar to that of the figures. Both plaques possess a fairly even, dark green patina, interrupted with some light green streaks, particularly on the Cook panel; the text does, however, remain legible. No fasteners were missing, and no surface damage or loss was otherwise observed.

Figures 29 and 30. Condition of the bronze plaques, commemorating the heroism of the war dead (left) and noting the generosity of the Cooks (right).

All bronze surfaces should be cleaned with an anionic detergent. Orvus WA Paste should be diluted 2-5% with clean water. Areas of soiling should be washed with additional detergent, scrubbed gently with soft brushes and rinsed with pressurized water (600-800 psi).

Following patination, the sculptures and plaques should receive a protective barrier coating of wax. The sculptures will be heated with a propane torch; two coats of new wax (National Parks Service formula) should be applied to the fully cleaned sculpture. Care should be taken not to direct the flame at the surrounding stone or to overheat the metal, particularly when treating the plaques. After the sculpture has cooled, a sacrificial top coat of Butcher's Bowling Alley cold paste wax should be applied to all bronze surfaces, allowed to dry and thoroughly buffed to a polish.
